# Easthampton New City Neighborhood Infrastructure Master Plan

## Appendices

June 2022

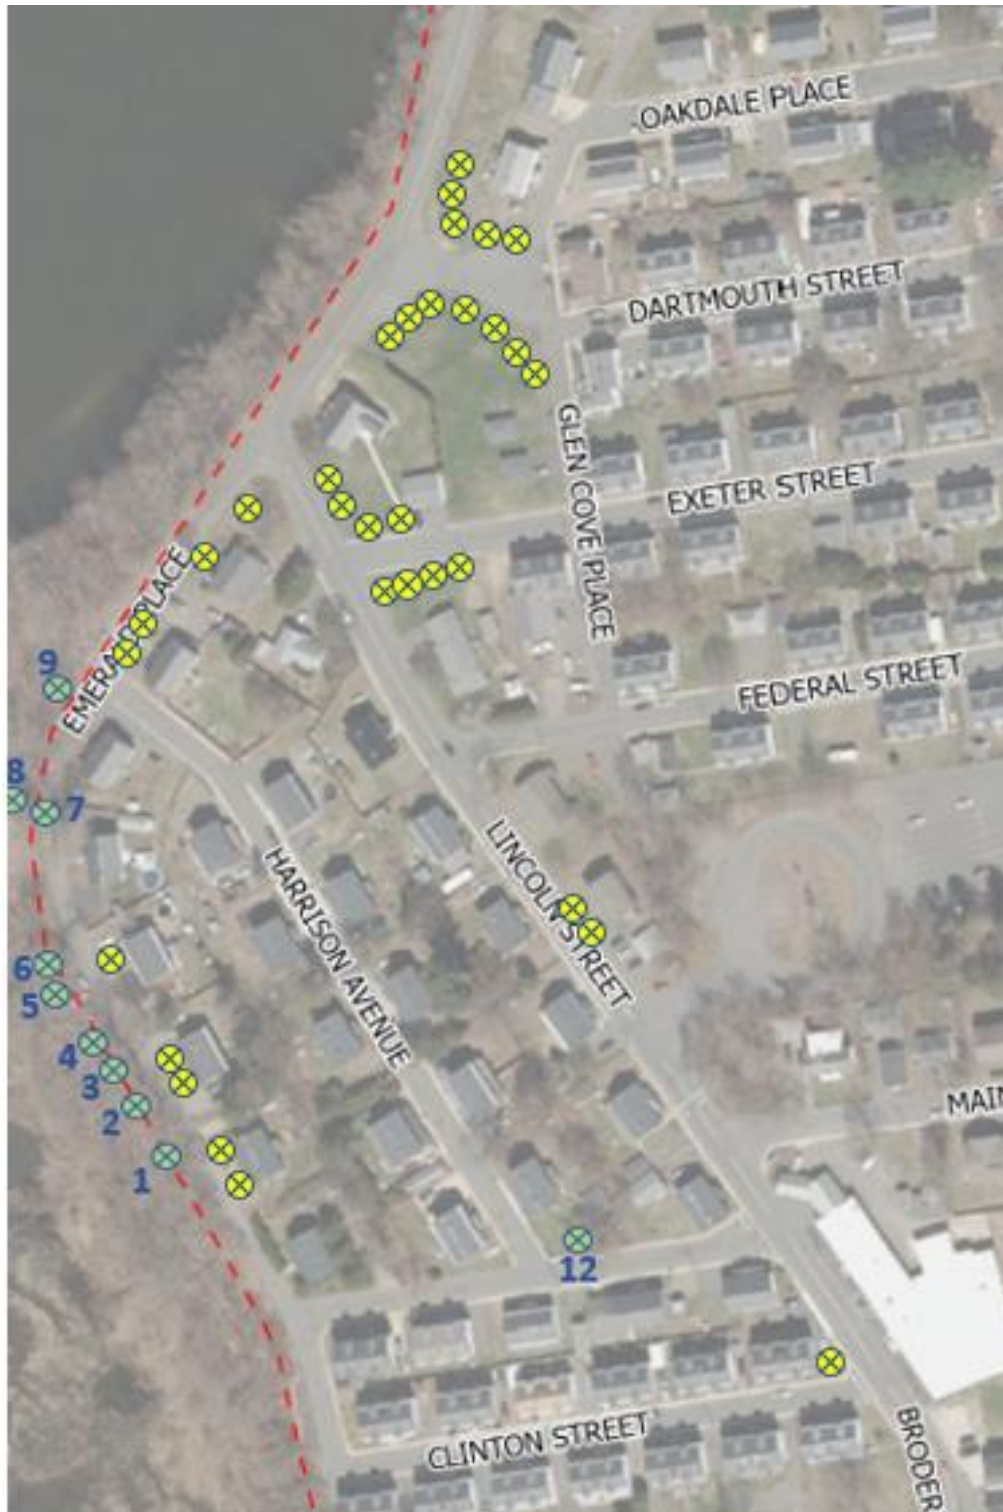
## Site Illustration 3 – Potential Planting Spaces

The above map is an enlarged copy of the west portion of the streetside tree map. All potential planting spaces are within this area except for Parson's Street Park. The yellow circles represent potential planting spaces within or close to the public right of way.

**Note:** the groups of circles in the north end represent multiple plantings. The recommended number and size are in the Planting Space data sheet on Page 11

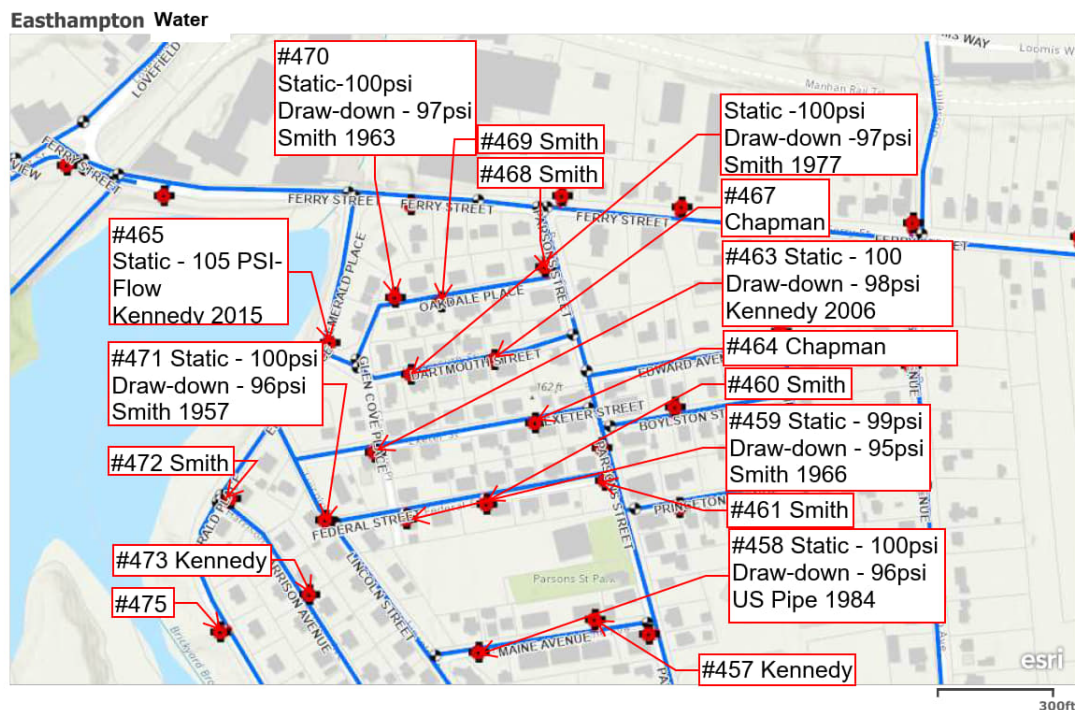
**Figure 1** – Hydrants Investigated in New City Neighborhood

The primary objectives of this Water System investigation were to perform Hydrant Flow Testing at 18 hydrants within the neighborhood and document the hydrants condition. The City's Water Staff assisted RH White Construction Company personnel in operating the valves and hydrants for the fire flow tests. The City did not want to run the fire flows for a long period of time due to their concerns with regard to pipe and hydrant conditions. The hydrants were slowly opened and flowed for a short period of time to see if there was a significant loss in pressure when the hydrant was opened. The pressure in the system was in the range of 92 to 100 psi before hydrants were opened and the system pressure only dropped slightly when the hydrants were opened: typically, 3 to 6 psi. A summary of the hydrants evaluated is shown in [Figure 1](#) and [Figure 2](#). The results of the fire flow testing are summarized in [Table 1](#).
